Advantage Inspection Service, Inc.

CONFIDENTIAL INSPECTION REPORT

489 N. Hardy, Phoenix, AZ.

04/02/2004 10:00 am to 1:00 pm

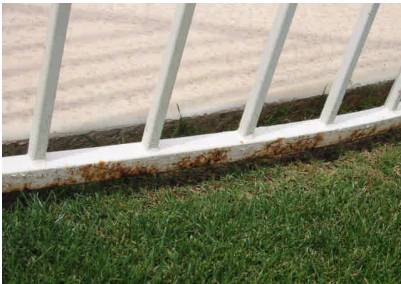
+ Fences and gates were Satisfactory except Adverse Conditions noted - Review.
+ Sections of the metal fencing are deteriorated or have rusting evident - Review.

→Sections of the metal fencing are deteriorated or have rusting evident - Review.

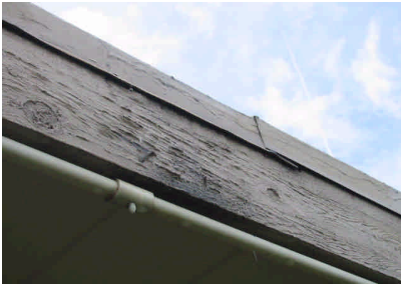
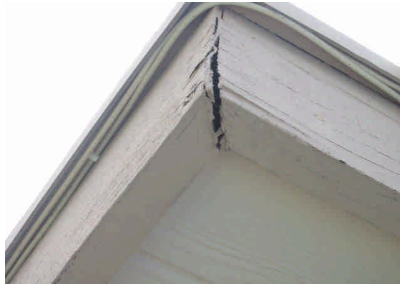
+ Deterioration and water stains were noted at fascia/soffit/trim areas, consult others to confirm source - Review.

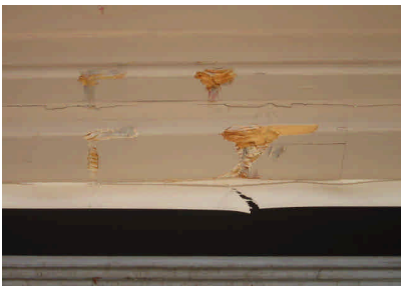
+ Damaged trim was observed at the garage door opening - Attention.

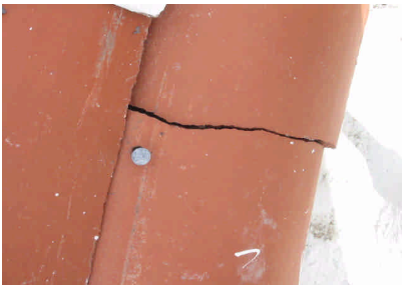
- + The clay tile roof appears to be Satisfactory except Adverse Conditions noted - Review.
- + Cracked roof tiles were observed - Monitor.

- +Cracked roof tiles were observed - Monitor.

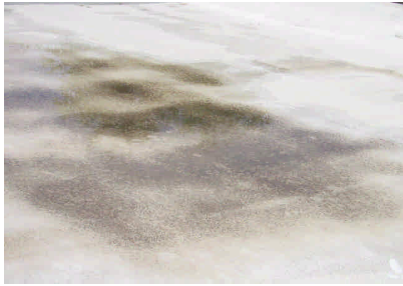
- + The foam roof was Satisfactory except Adverse Conditions noted - Review.
- + Ponding evident at foam roof - Monitor.

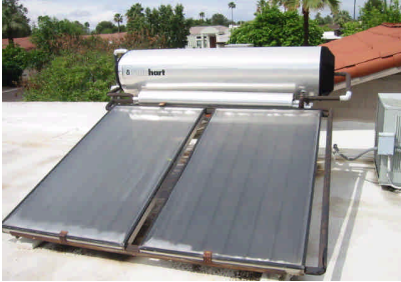
Water heater location - roof (part of solar system).

The solar water heater is not part of this inspection, consult an expert to evaluate the system for function and safety - Review.

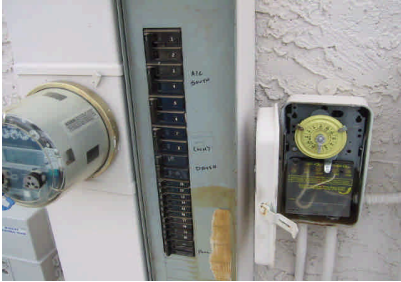
+ The main panel was Satisfactory except Adverse Conditions noted - Review.

+ Various circuits within the main panel need to be labeled - Safety Note.

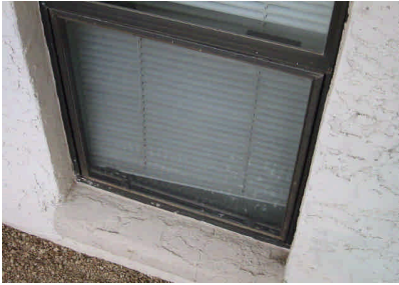
+ The master bedroom egress windows are too small to meet current building standards - Safety Note.

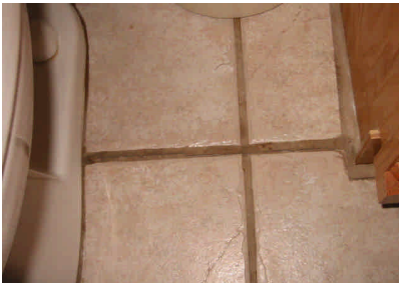
+ The flooring appeared Satisfactory except Adverse Conditions noted - Review.

+ The tiled floor has cosmetic cracks/damage, that you may want to evaluate for yourself - Review.

+•The tiled floor has cosmetic cracks/damage, that you may want to evaluate for yourself - Review.

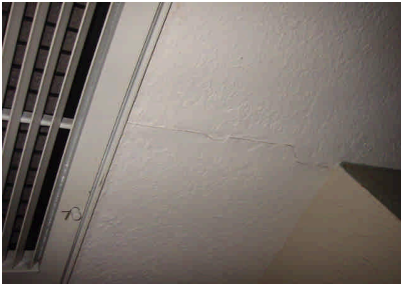
+ The walls and ceilings were Satisfactory except Adverse Conditions noted - Review.

+ The walls/ceilings need typical crack repairs, correct imperfections as required - Attention.

+•The walls/ceilings need typical crack repairs, correct imperfections as required - Attention.
